FAILURE ANALYSIS OF FUEL INJECTION PUMPS FROM GENERATOR SETS FUELED WITH JET A-1

**INTERIM REPORT
BFLRF No. 268**

Belvoir Fuels and Lubricants Research Facility (SwRI)

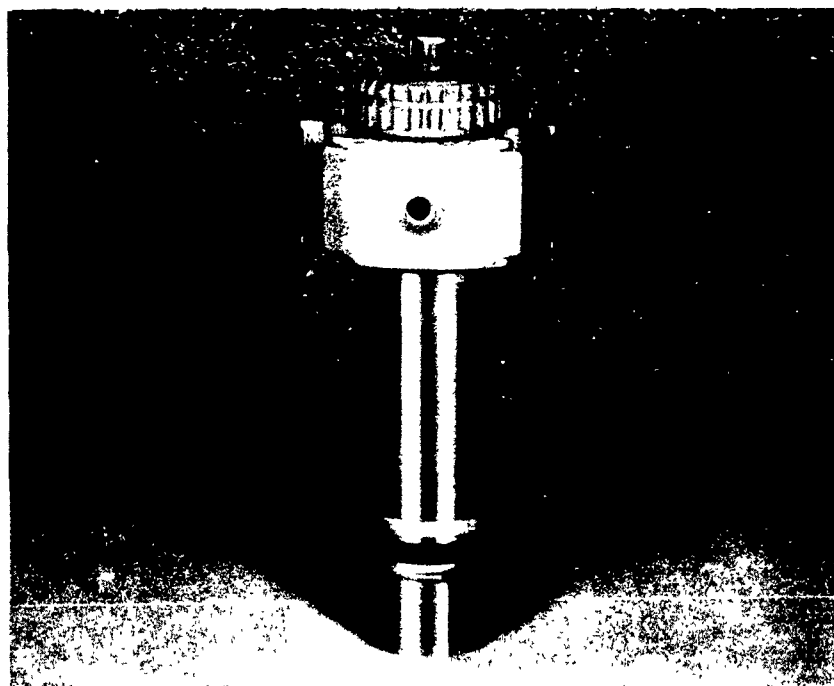
In running the engine with diesel fuel, seizure at this position normally indicates that excessive side thrust is occurring at the transfer pump, due either to mechanical or hydraulic loading. Such loading is normally caused by one of the following:

Figure 3. Rotor from Pump No. 5545723
[Note: Abraded ring caused by seizure (close to transfer pump at the bottom of the picture).]

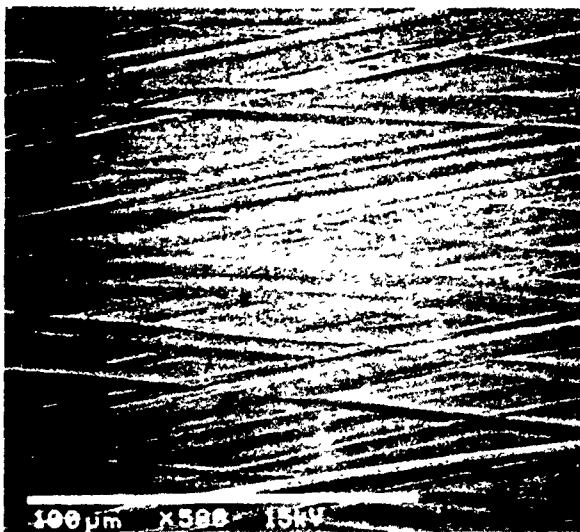
Figure 8. Representative machining marks on metering valve

After completion of the pump tests, the bores from Pump Nos. 2, 3, and 4 were cut from the hydraulic heads and sectioned parallel to the axis of the valve using an electric discharge machine (EDM). Almost no material was lost during the cutting process, and the complete surface of the valve bore was then available for examination. Machining marks were visible on the surface of each bore and valve spindle, as shown in Fig. 8.
